REPORT
ON THE
RENEWAL
OF
NIAGARA SUSPENSION BRIDGE.

BY
LEFFERT L. BUCK,
CIVIL ENGINEER.

1880.

ON THE REINFORCEMENT OF THE ANCHORAGE AND RENEWAL OF THE SUSPENDED SUPERSTRUCTURE OF THE NIAGARA RAILROAD SUSPENSION BRIDGE.

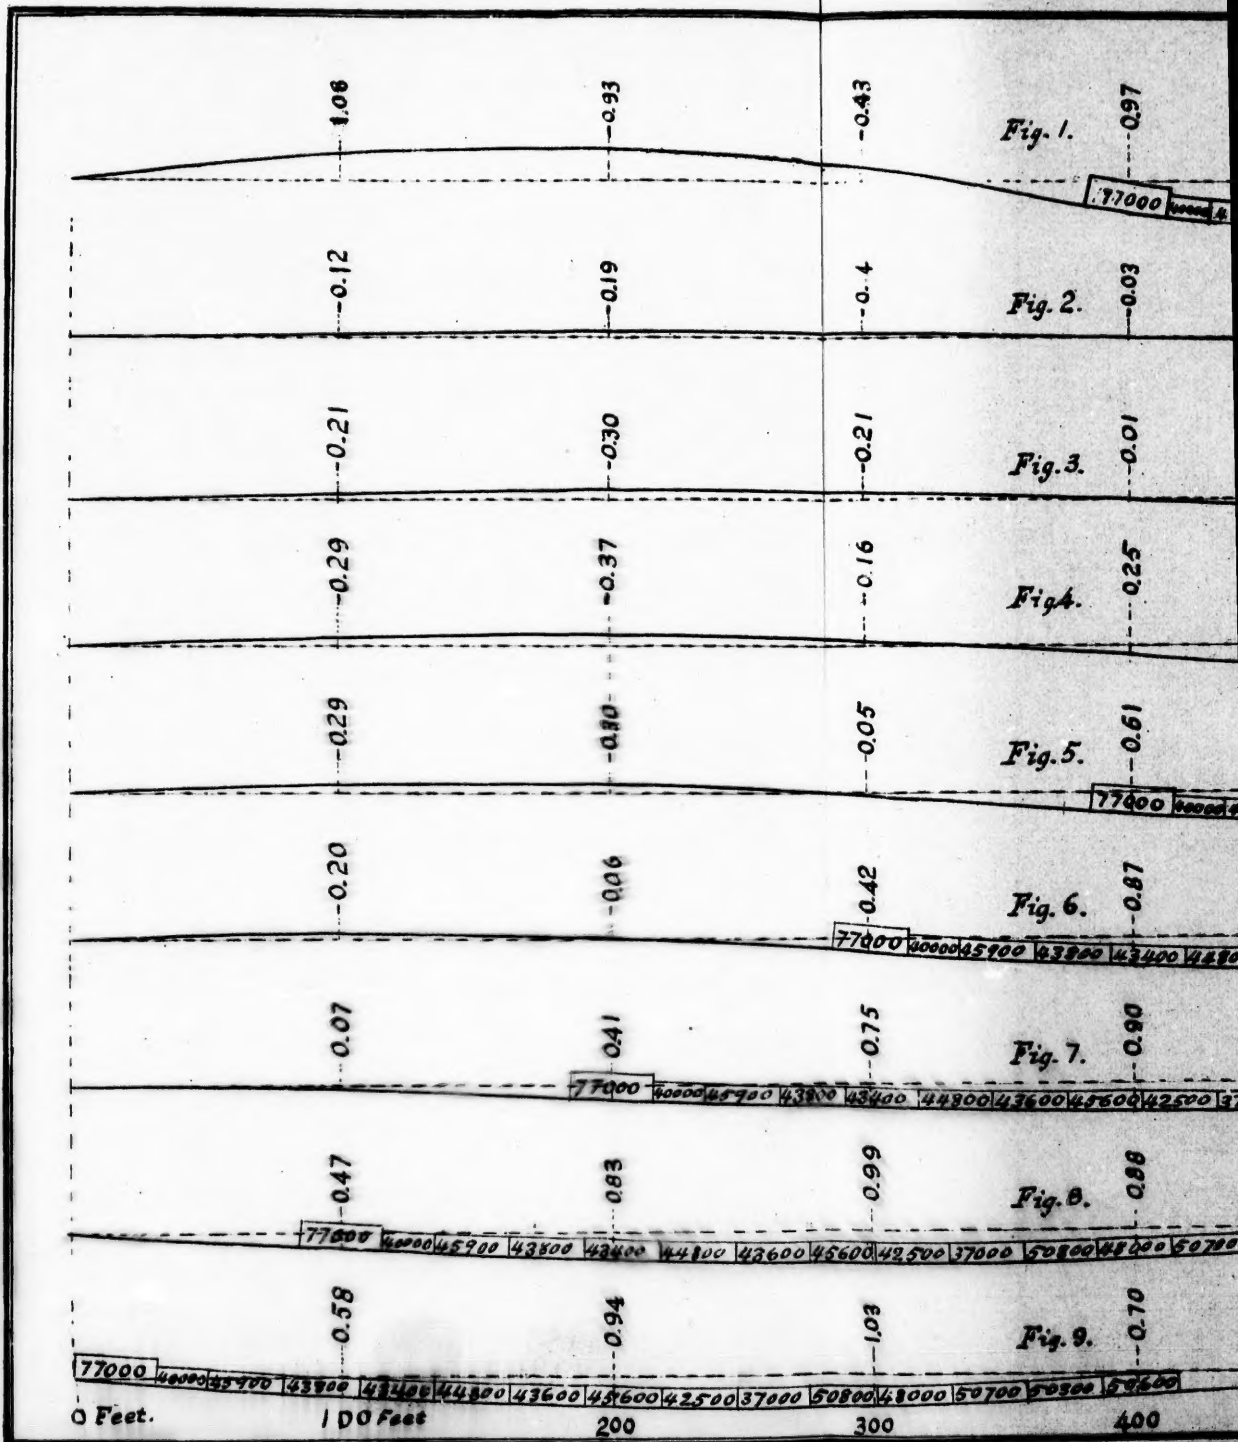
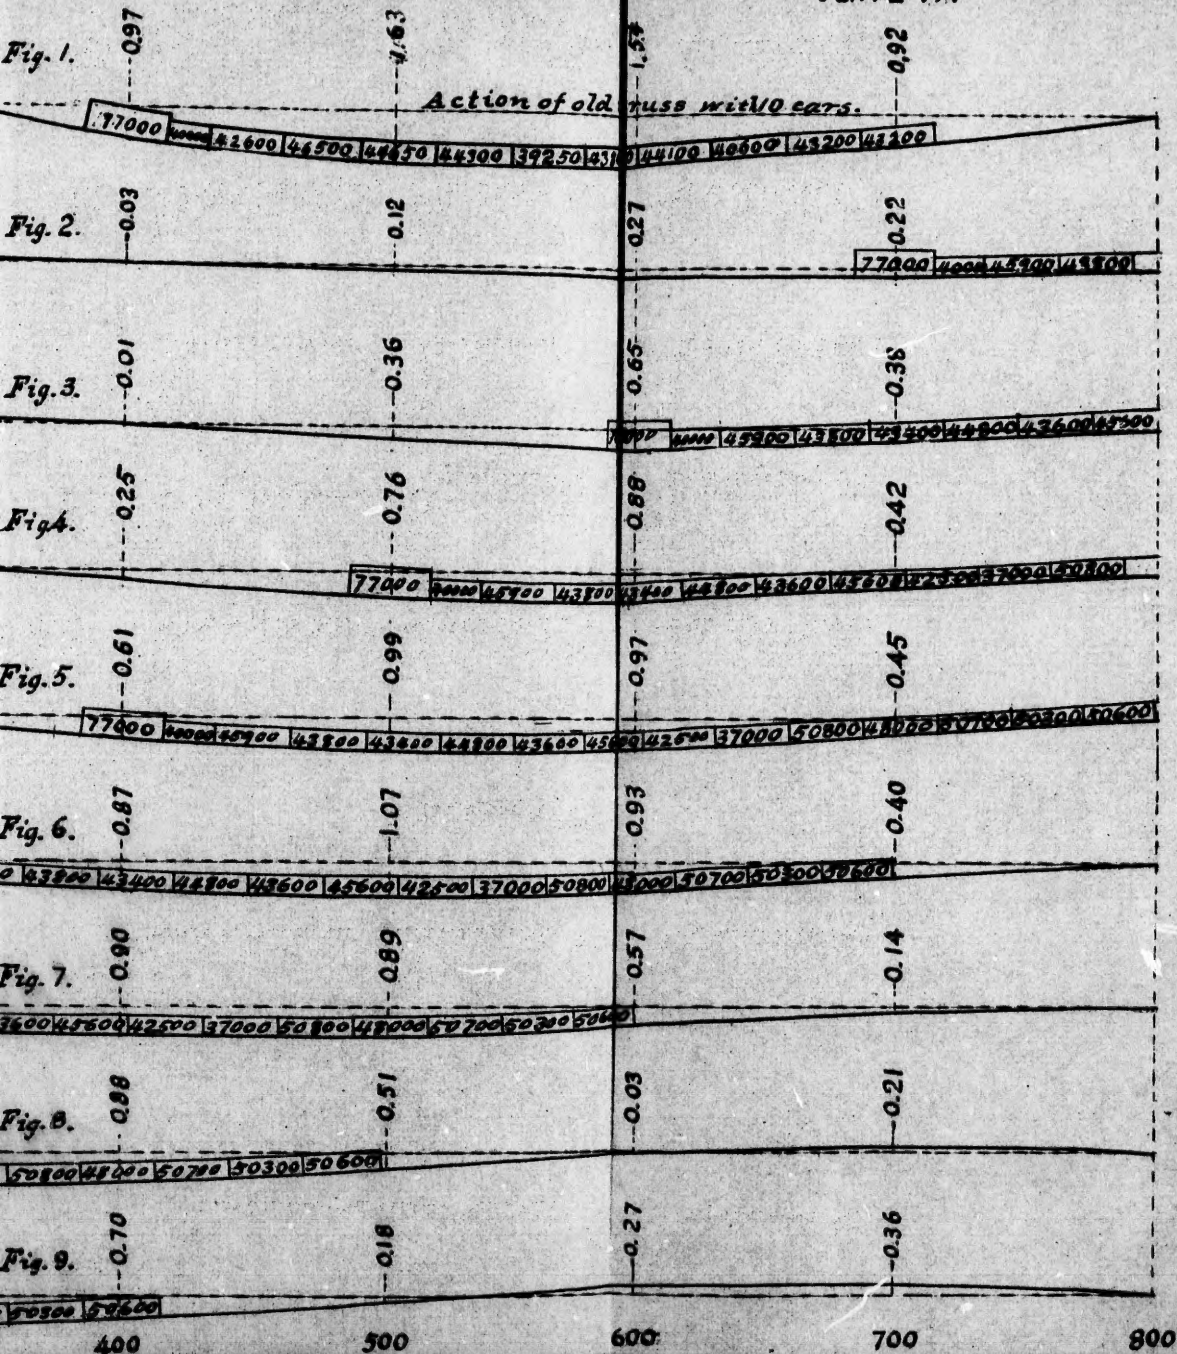
PLATE VI.

Fig. 1, Plate VI is to show the action above described.

2d. ACTION OF THE OVERFLOOR STAYS — Fig. 1, Plate VI is to assist in explaining this.

The actual deflections, under a load consisting of an engine, tender and thirteen box cars loaded, having a total weight of 357 tons, are given for eight different positions of the load by Figs. 2 to 9 inclusive (Plate VI). The total length of the train was 465 feet. In the diagrams the vertical scale is 12.5 times as great as the horizontal scale. Fig. 2, Plate V, is constructed from Fig. 5, Plate VI.
